AIRCRAFT ACCIDENT REPORT

IN-FLIGHT FIRE/EMERGENCY LANDING
FEDERAL EXPRESS FLIGHT 1406
DOUGLAS DC-10-10, N68055
NEWBURGH, NEW YORK
SEPTEMBER 5, 1996

**Adopted: July 22, 1998
Notation 6800B**

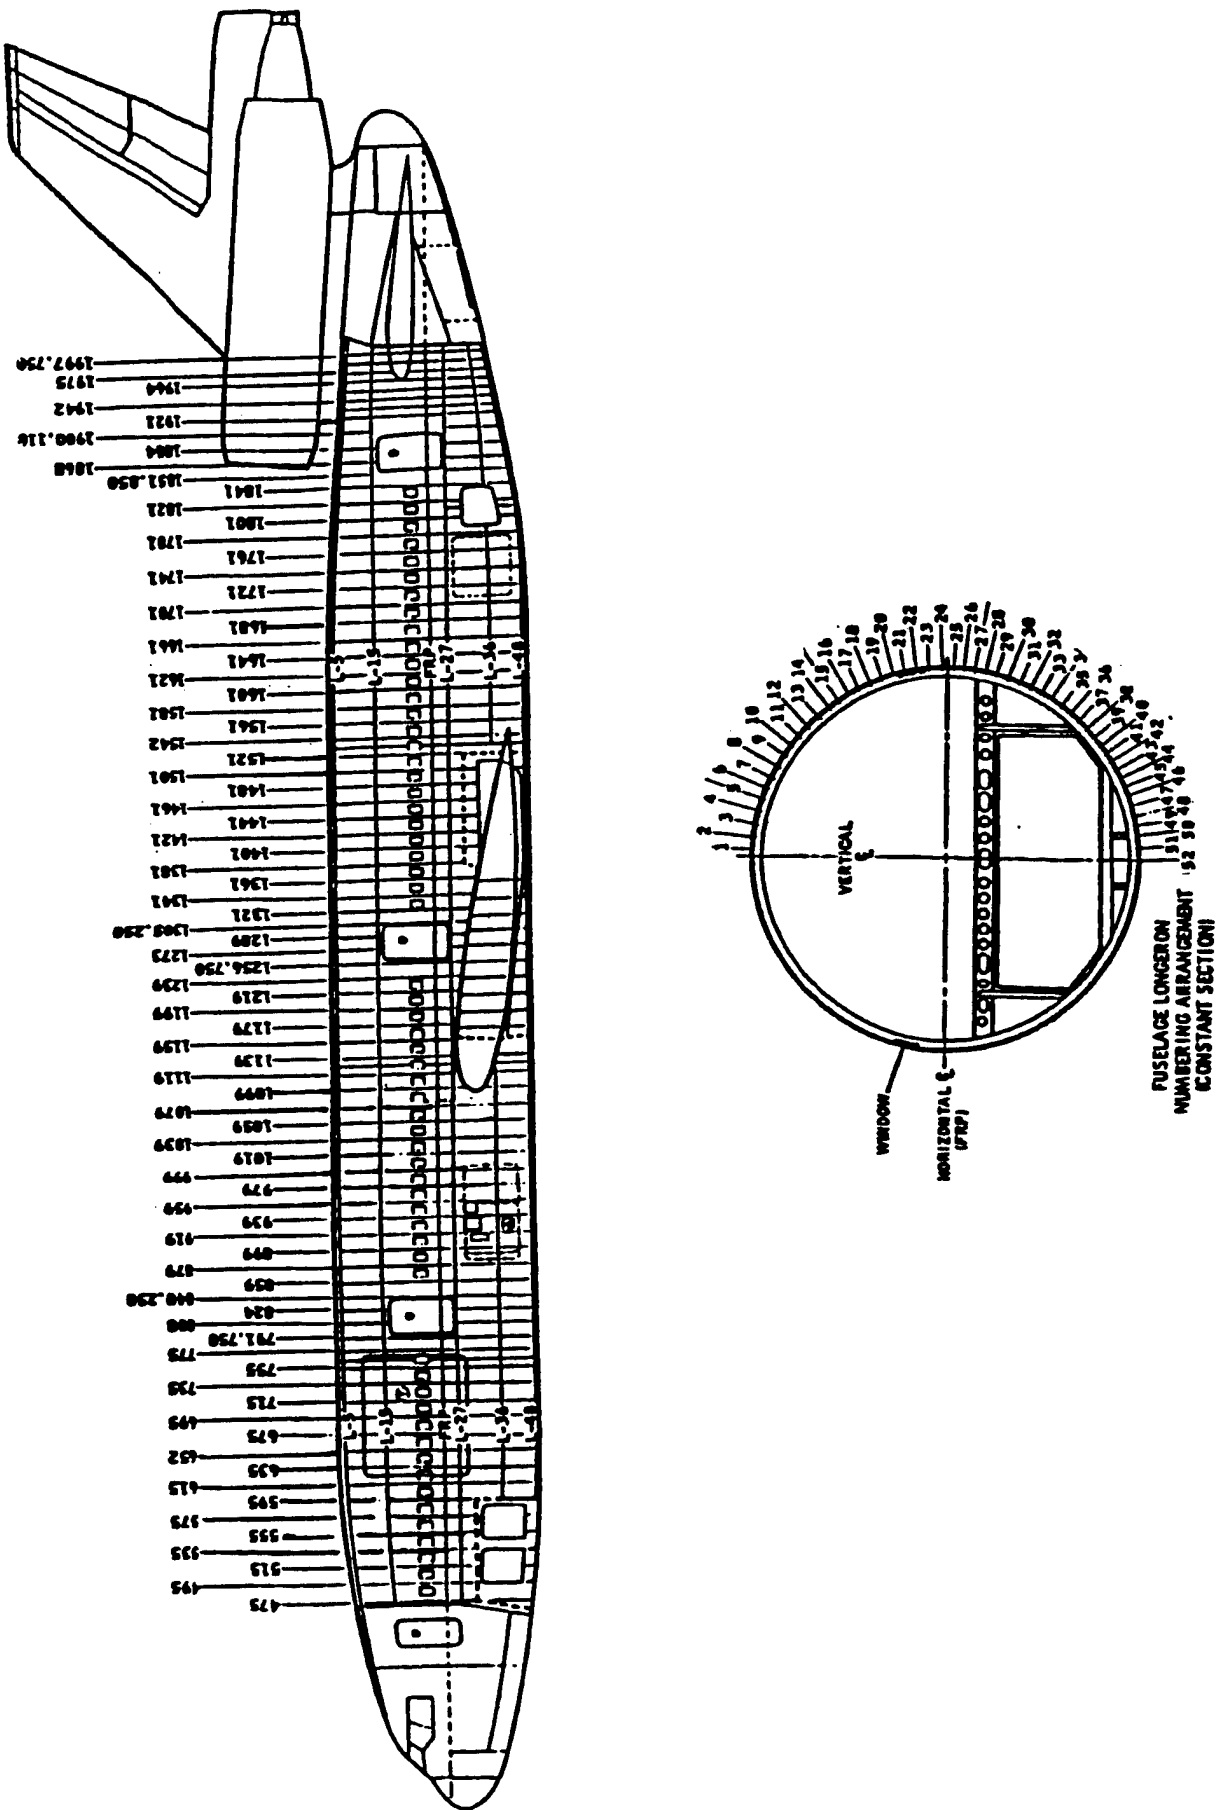
Figure 6.—DC-10-10, N68055, fuselage station and longeron number locations.

At the separated empennage section, the upper interior fuselage crown and the canted area of the aft pressure bulkhead were heavily sooted between longeron 15 left and longeron 23 right. Four of the upper fuselage ring frames were burned and melted between longeron 1 left and the upper canted bulkhead, parallel to longerons 18 left and right. The No. 2 engine bleed air duct was separated about 3 feet forward of the bulkhead. Electrical wires protruded about 20 feet from the aft pressure bulkhead and had cut and separated ends. The wire insulation remained intact on the wires that protruded from the left side of the aft pressure bulkhead, and the wire insulation was burned around the wires that protruded from the right side of the aft pressure bulkhead. No evidence of arcing of airplane wiring was seen. The lower section of the aft pressure bulkhead that was common to the lower cargo area was undamaged and had no soot or fire damage.

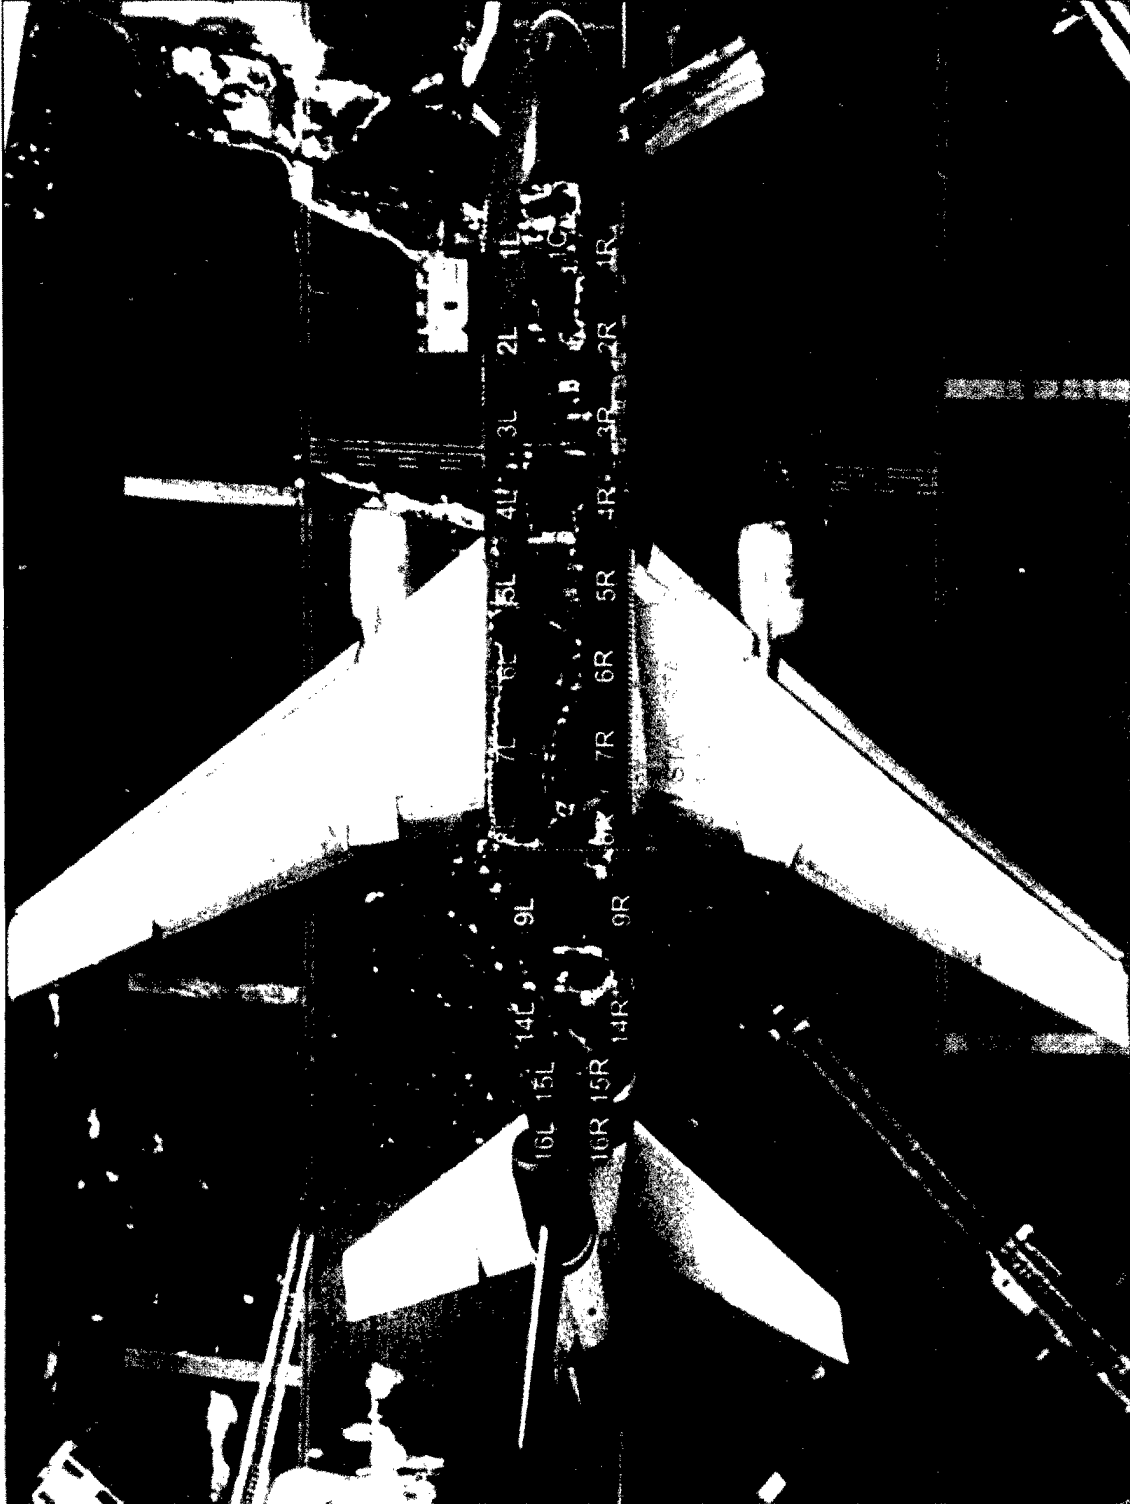
Figure 7.—DC-10-10, N68055, airplane with overlaid cargo container positions.

There were melted and partially consumed aluminum fuselage skin, longerons, and frames³¹ throughout the interior fuselage. The cabin interior of the forward fuselage was burned and sooted between FS 470 and 765. The cabin sidewall panels in that area were destroyed by fire on the right side of the fuselage, exposing the burned and melted fuselage ring frame flanges. The center of the fuselage crown was consumed by fire from FS 515 through 575, above container row 1. (See figure 7.) Two small areas of fuselage crown were consumed by the fire between FS 595 and 615 on the right side of the fuselage and between FS 615 and 635 on the left side of the fuselage, also above container row 1. The center of the fuselage crown was consumed in the area of the main cabin cargo door from FS 635 through 735, above the location of cargo container row 2.

The cabin sidewall panels were lightly sooted and remained attached to the left side of the fuselage between FS 450 and 840, above container position 3L. Burned and sooted upper sidewall panels hung down directly above the attached lower sidewall panels. The right side of the fuselage between FS 808 and FS 919, next to container position 3R, exhibited severe heat and fire damage, along with melted fuselage frame flanges. The airplane's exterior paint was scorched and bubbled on the left side, next to the first two windows between FS 859 and 899, near the aft of container row 3 and the front of container row 4.

The fuselage crown was consumed by the fire between FS 939 and FS 1039, from approximately the middle of container row 4 to the middle of container row 5. The frame flanges on either side of this consumed area of the fuselage crown were burned and melted. The left side of the fuselage crown was also consumed by fire between FS 1179 and FS 1531, an area corresponding to approximately the middle of cargo container 6L to the middle of cargo container 9L.
